TEST REPORT

Lucideon Reference: 184360 (QT50784/2/GMB)/Ref. 1

Project Title: Testing of Forterra Brick Slip Cladding System in Accordance with ETAG 034:2012 Guideline for Technical Approval of Kits for External Wall Cladding

Client: Forterra Building Products Ltd
Measham Works
Atherstone Road
Measham, Swadlincote
Derbyshire
DE12 7EL

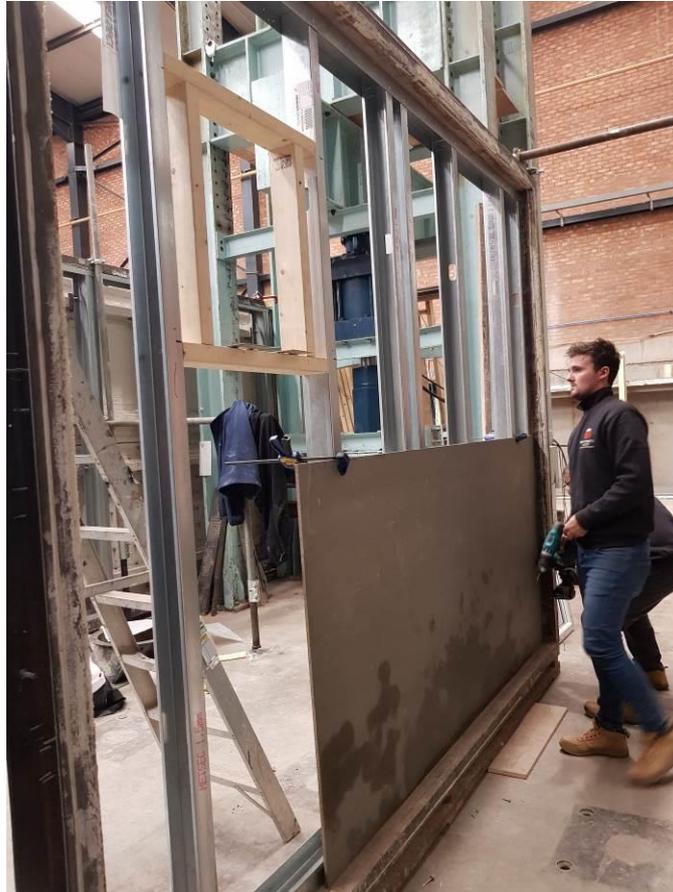
Plate 1 – Mechanically Fixing of the Cement Particle Board onto the Galvanised Metal Frame Previously Installed

2400 x 1200 x 10 mm RCM Cement Particle Board was fixed to the galvanised metal frame at 300 mm vertical centres. Joints in the board were taped using tremco illbruck ME315 Contractors adhesive tape.

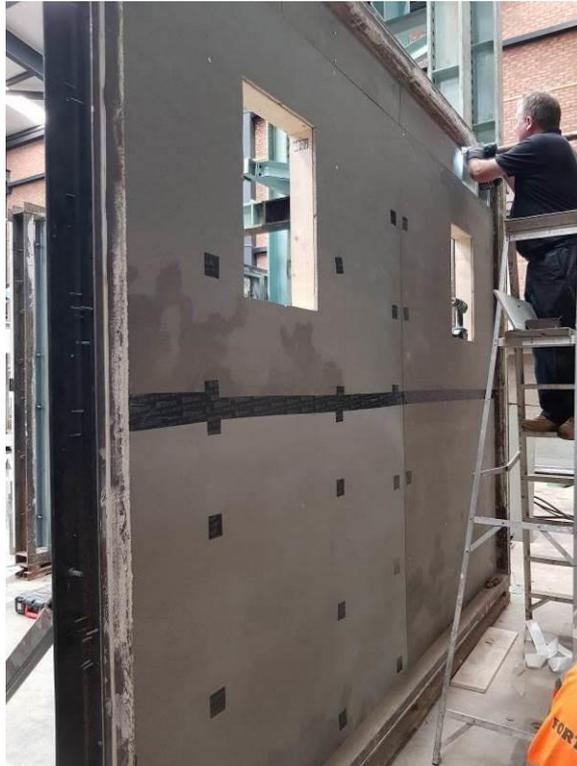
Plate 2 – View of Joint Taping Cement Particle Board

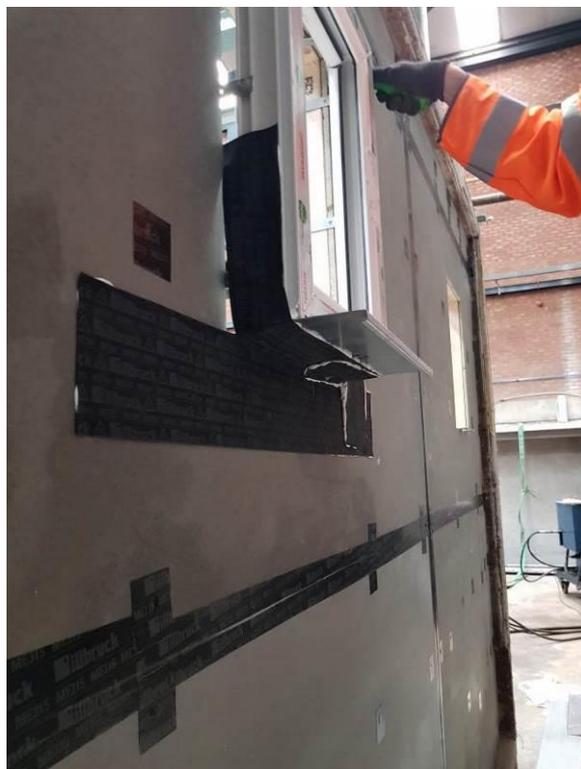
Plate 3 – View of the 'DPC Installed to Window Perimeter

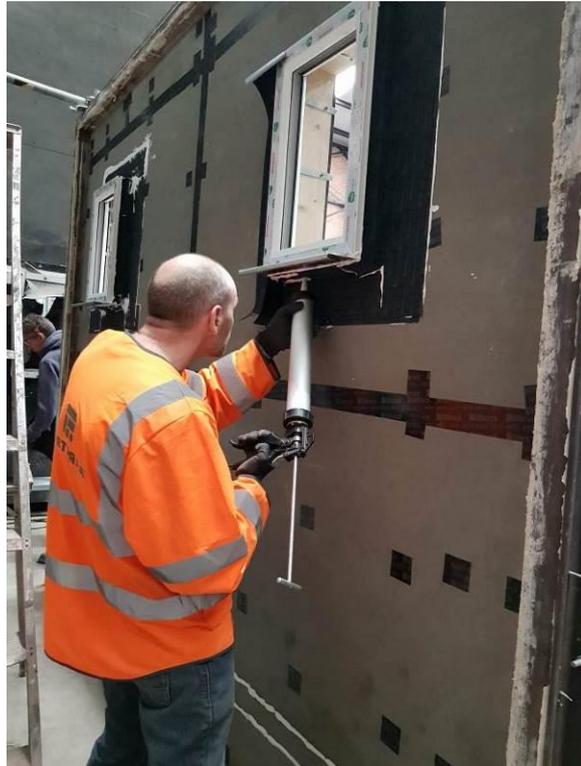
Plate 4 – View of the 'DPC Installed to Window Perimeter and Cement Particle Board

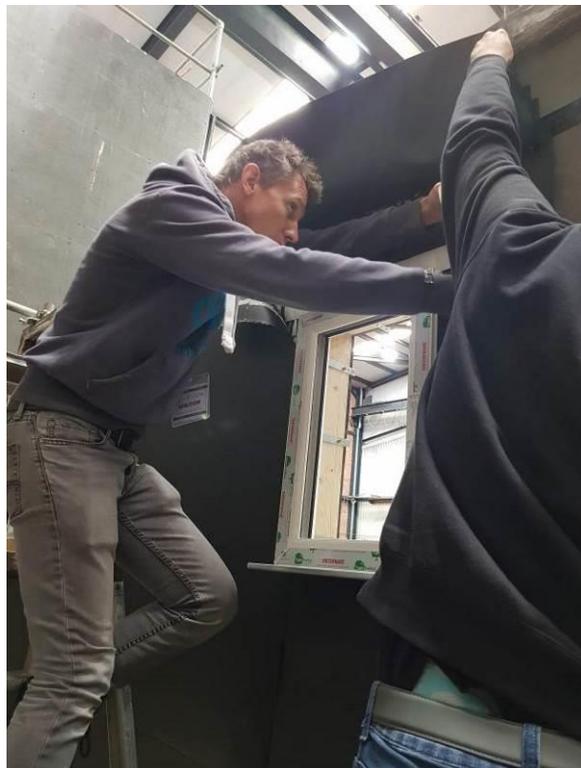
Plate 5 – View of Installation of Breather Membrane

tremco illbruck ME 011 breather membrane UV was dab fixed to the cement particle board using tremco illbruck SP525 adhesive.

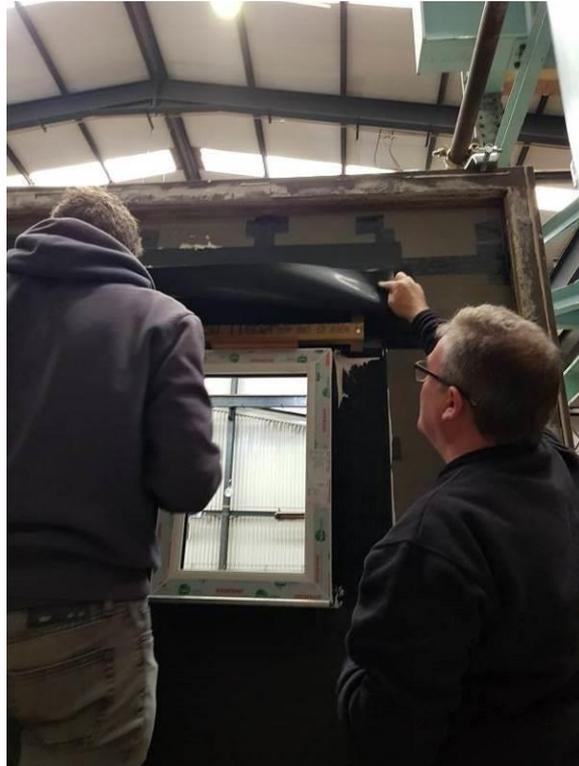
Plate 6 – Installation of Frame for Soldier Detail

A timber frame constructed from 48 mm x 48 mm treated timber was fixed using EJOT TKE 4.8 mm x 100 mm to the wall above the window to enable vertical fixing of the brick slips to incorporate a soldier course detail above the window.

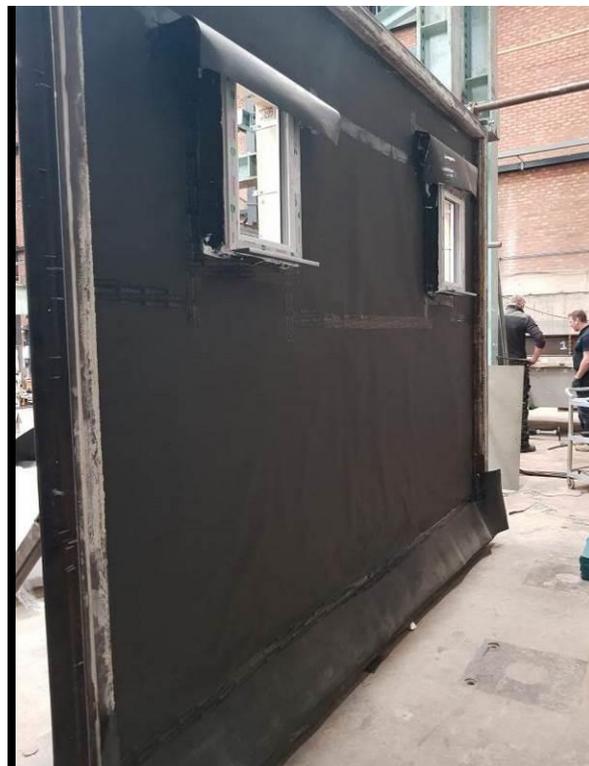
Plate 7 – Wall after Installation of Breather Membrane

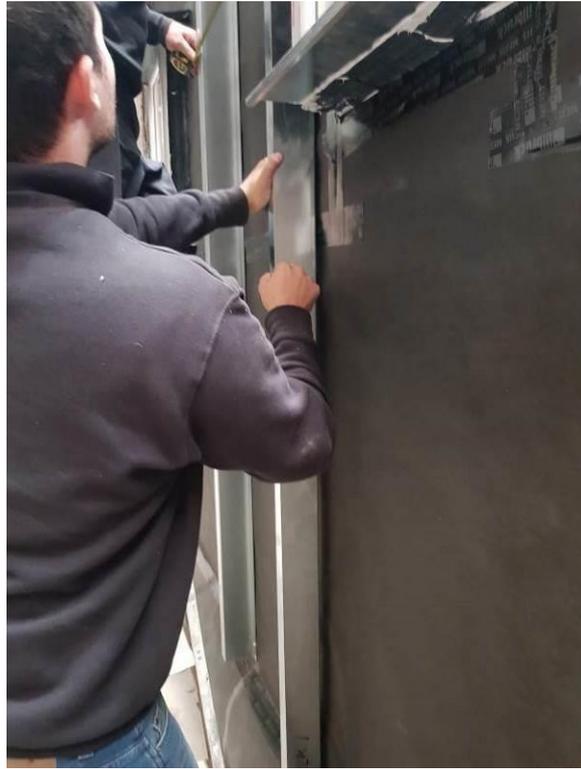
Plate 8 – Installation of Zed Rails

Walker Steel Zed rails were fixed through the breather membrane and cement particle board into the galvanised steel frame. The zed rails were fixed to give 600 mm centres in the centre of the frame and 280 mm at either end. The rails were fixed using EJOT JT3 4.9 mm x 35 mm fixings at 300 mm vertical centres.

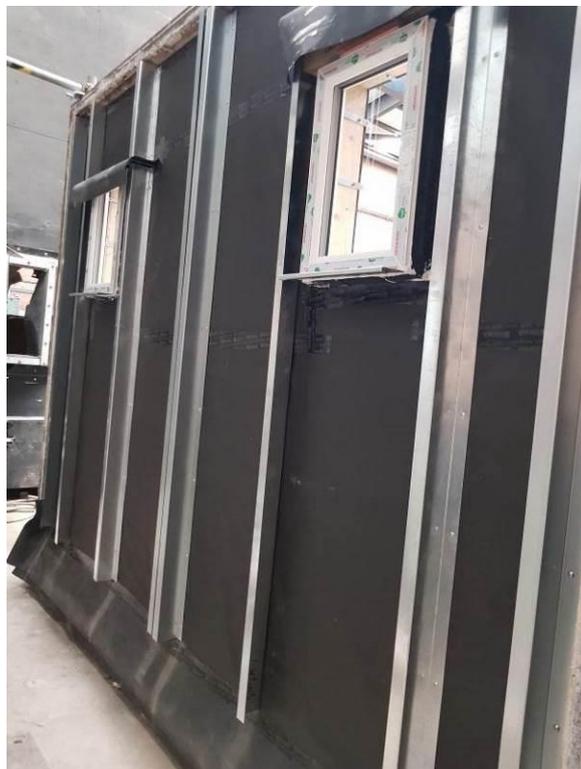
Plate 9 – Wall on Completion of Zed Rail Install

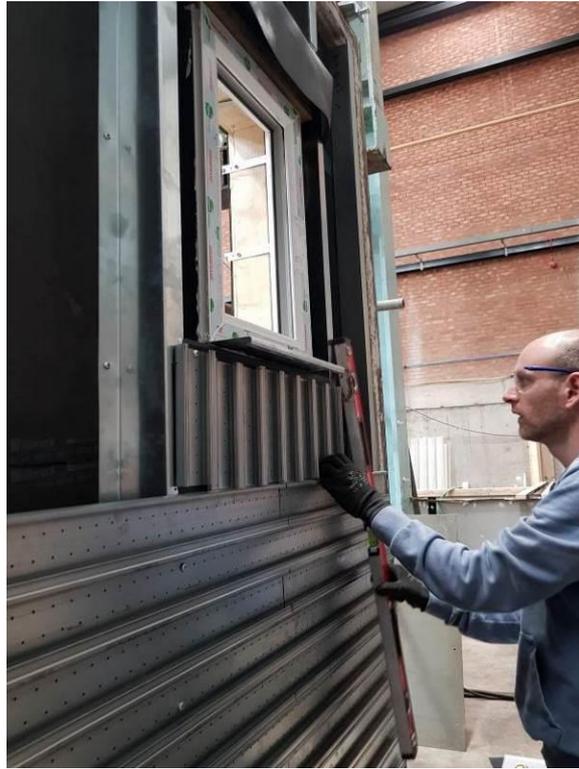
Plate 10 – Installation of Brick Rail

SureBrick stainless steel cladding rails were fixed to the Zed rails at a maximum of 106 mm vertical centres with EJOT JT3 5.5 mm x 25 mm fixings.

SureBrick Rails were fixed with butt joints located between the vertical zed rails. The maximum distance from a zed rail to a joint i.e. the end of a cantilevered SureBrick rail was 500 mm.

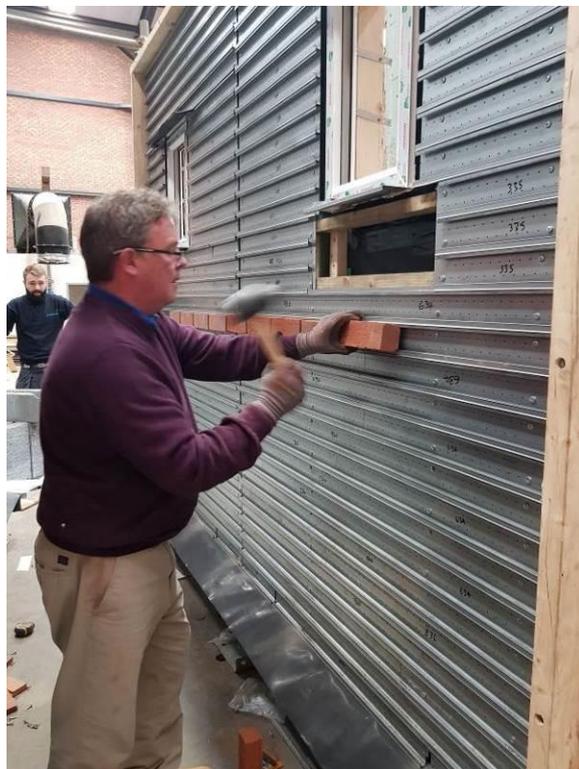
Plate 11 – Installation of Brick Slips

The wall was split vertically with Forterra Dark Multi Smooth brick slips used on one side of the installation and Forterra Chelsea Smoked Red used on the other. The brick slips were located in the metal cladding rails using a rubber mallet.

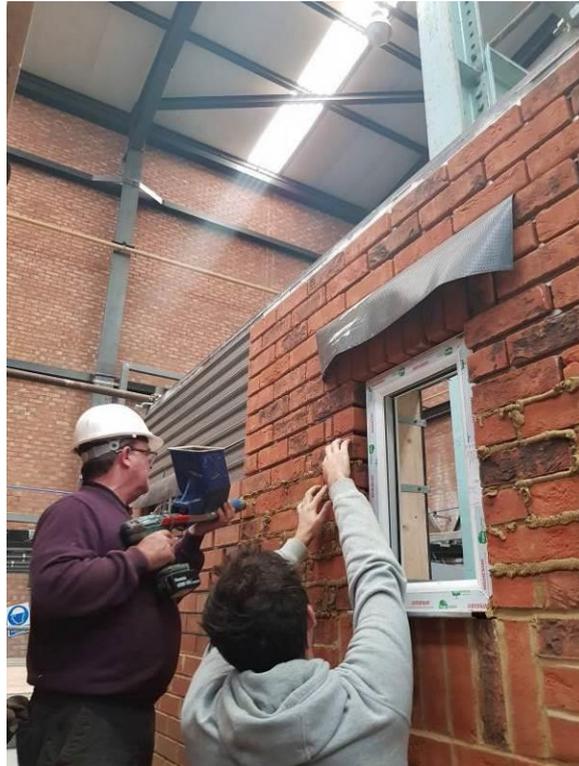
Plate 12 – Application of Pointing Mortar

25 Kg of mortar was mixed with 3.75 litres of water with a paddle mixer to produce a mortar with a consistency of finishing plaster. It was allowed to stand for 5 minutes and then remixed.

The brick slips were then pointed using a pointing gun. The mortar was allowed to cure for several hours and then finished by scraping with a spatula.

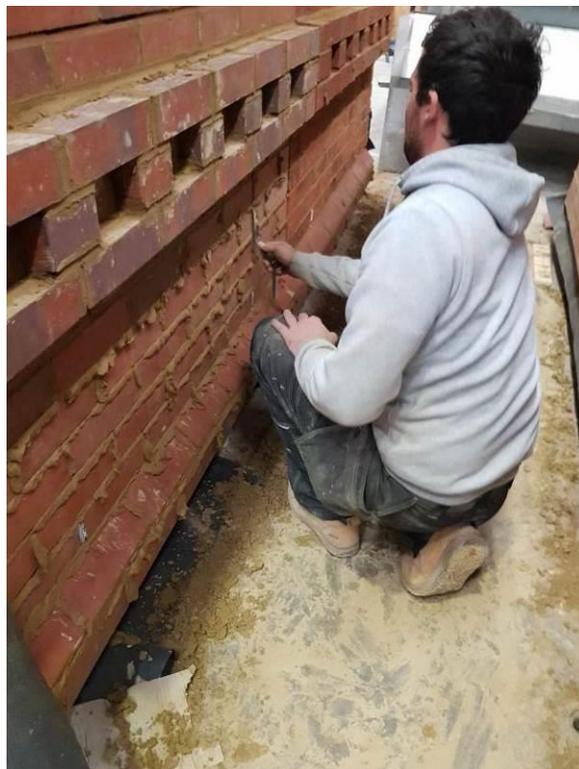
Plate 13 – Finishing of Mortar Joint

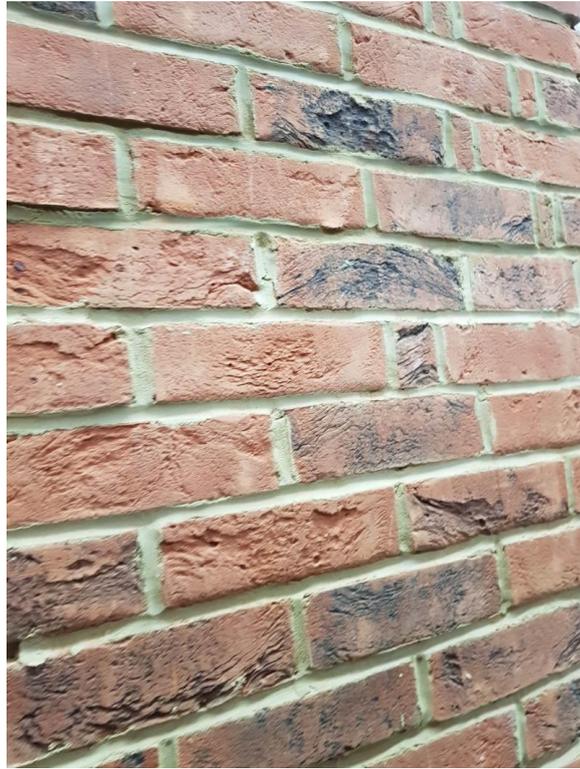
Plate 14 – Finished of Joints

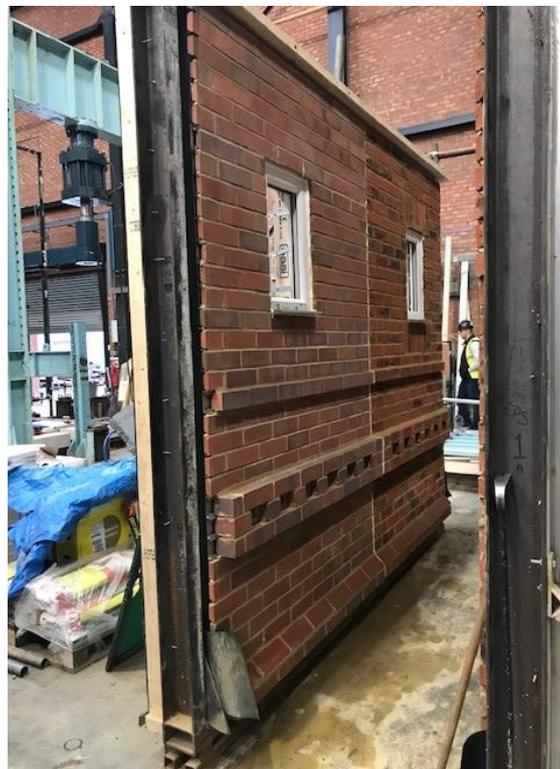
Plate 15 – Finished Wall

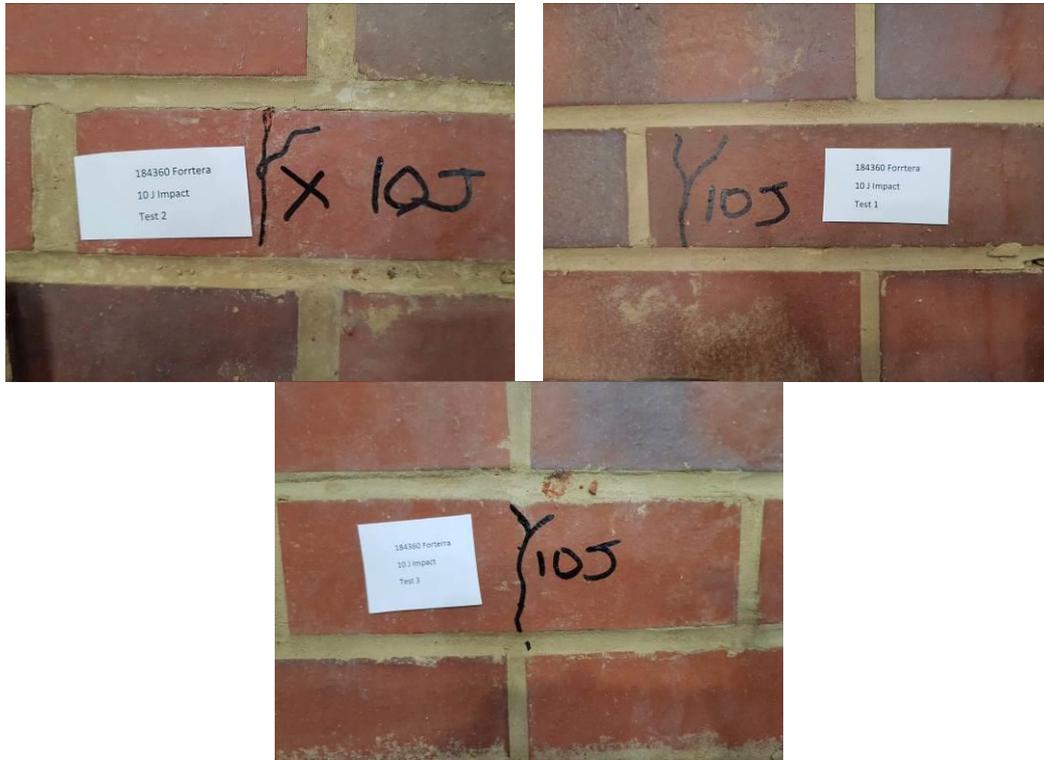
Plate 16 – Dark Multi Smooth Brick Slip Hard Body Impact Tests (10 Joules)

Forterra Dark Multi Smooth Brick Slips	Vertical Crack
Forterra Chelsea Smoked Red Brick Slips	No Damage

Location	Under 3 Joules Impact Energy (mm)	Under 10 Joules Impact Energy (mm)
1	No damage recorded	Vertical Hairline Crack Through Brick Slip
2	No damage recorded	Vertical Hairline Crack Through Brick Slip
3	No damage recorded	Vertical Hairline Crack Through Brick Slip

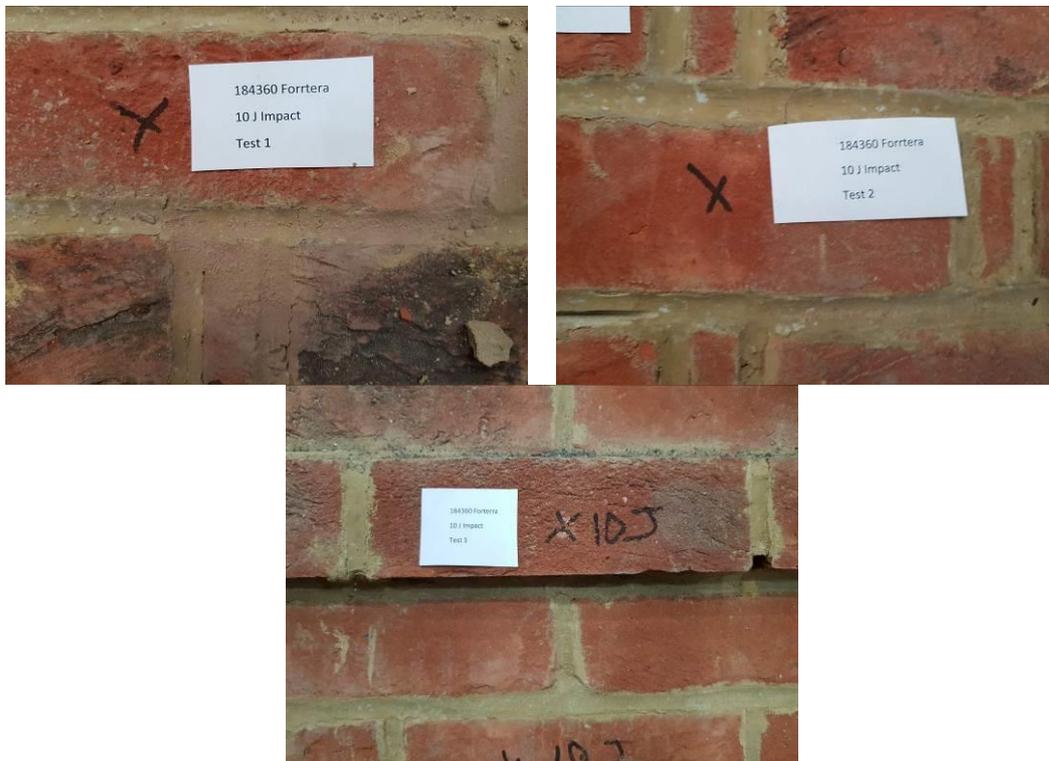
Plate 17 – Chelsea Smoked Red Brick Slip Hard Body Impact Tests (10 Joules)

Location	Under 3 Joules Impact Energy (mm)	Under 10 Joules Impact Energy (mm)
1	No damage recorded	No damage recorded
2	No damage recorded	No damage recorded
3	No damage recorded	No damage recorded

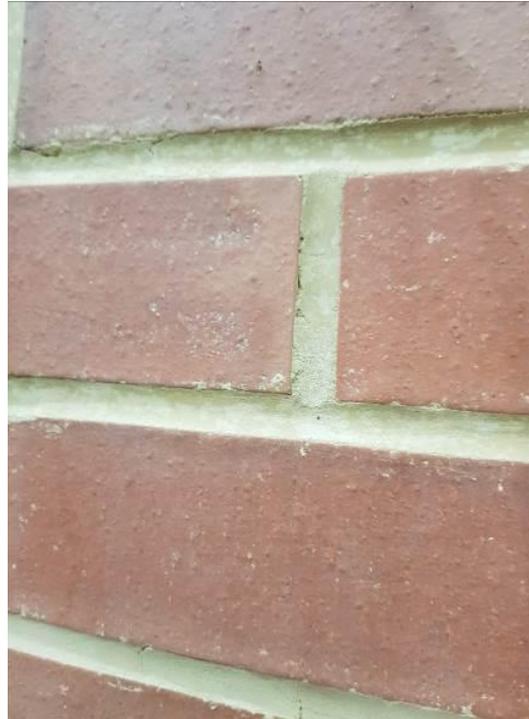
Plate 19 – Soft Body Dark Multi Smooth Brick Slip 400 Joules – No Damage

Impact Energy (Joules)	Observations
10	No damage recorded
60	No damage recorded
300	No damage recorded
400	No damage recorded

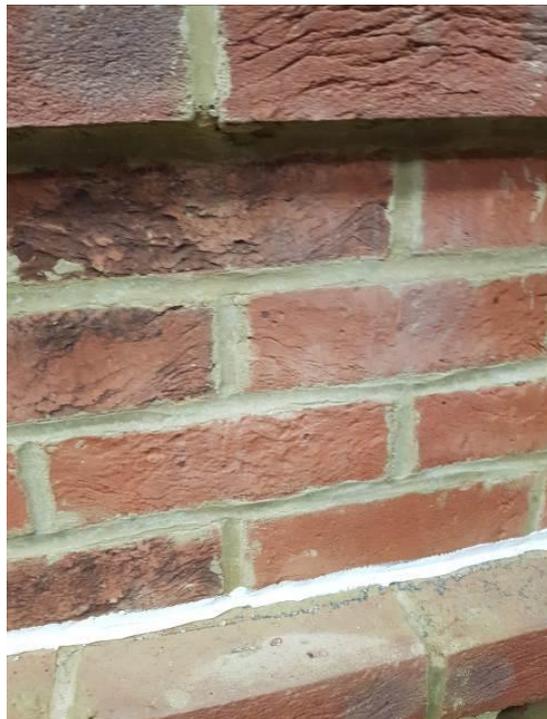
Plate 20 – Soft Body Impact Test Chelsea Smoked Red Brick Slip 400 Joules – No Damage

Impact Energy (Joules)	Observations
10	No damage recorded
60	No damage recorded
300	No damage recorded
400	No damage recorded

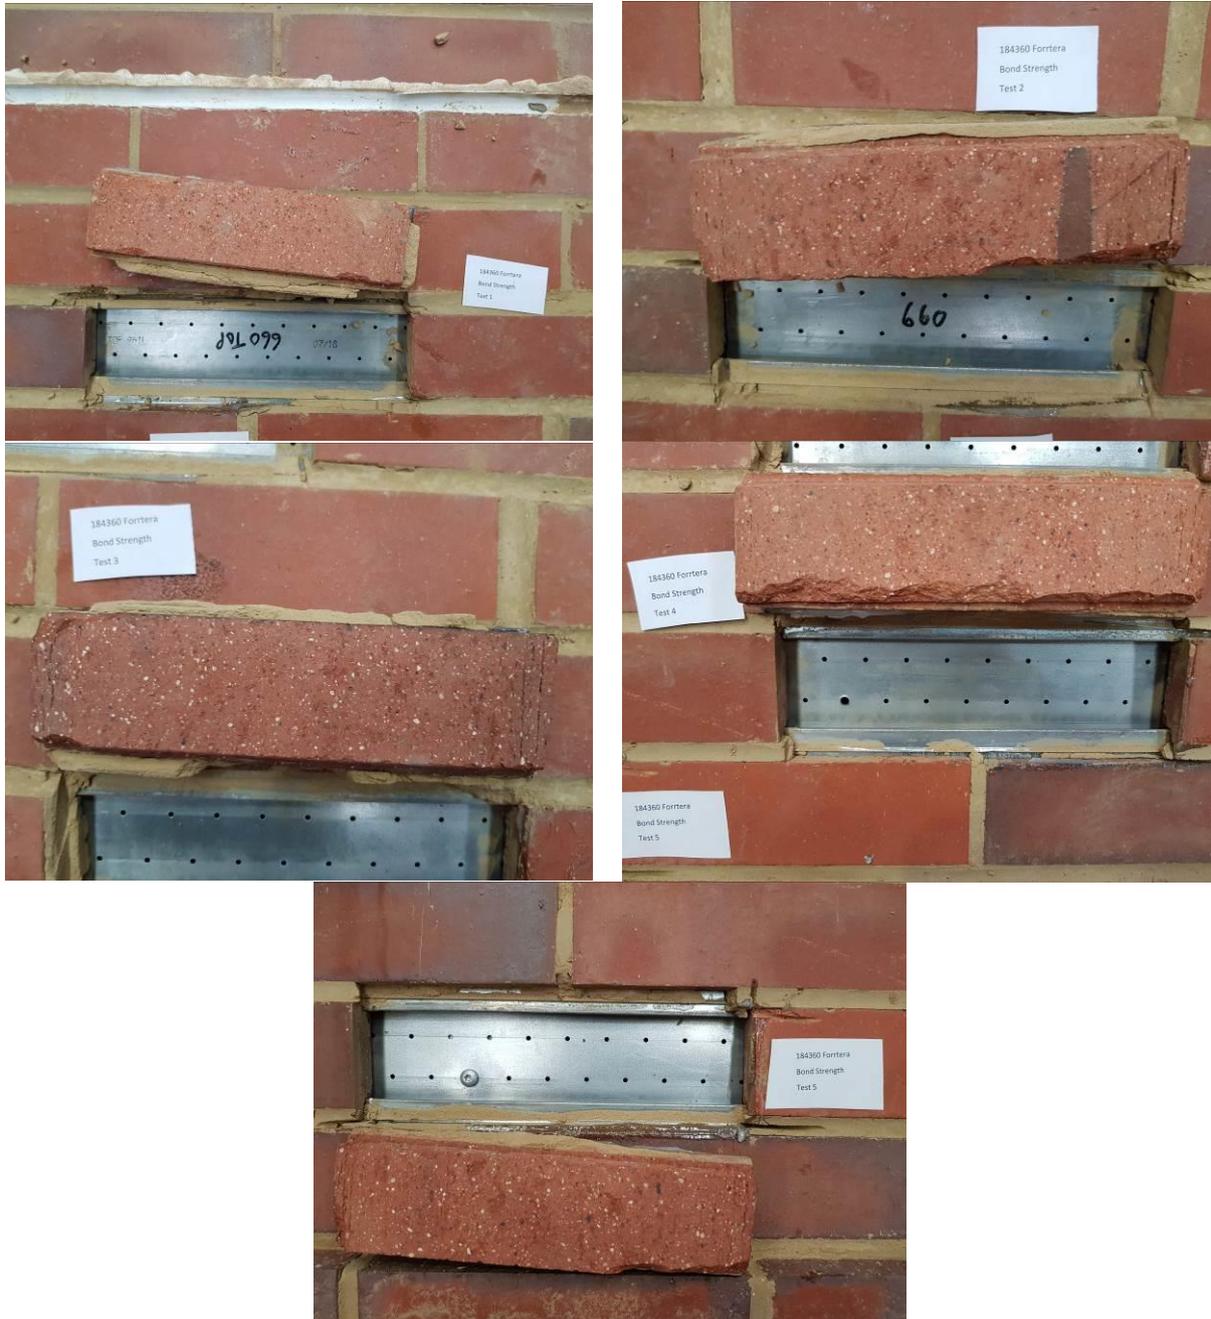
Plate 21 – Dark Multi Smooth Brick Slips Bond Strength Tests – after Hygrothermal, Freeze/Thaw Testing and Water-Tightness Testing

Location	Pull-Off Strength (N/mm ²)	Mode of Failure
1	0.243	Pull Out From Rail
2	0.126	Pull Out From Rail
3	0.164	Pull Out From Rail
4	0.195	Pull Out From Rail
5	0.081	Pull Out From Rail
Mean	0.162	-

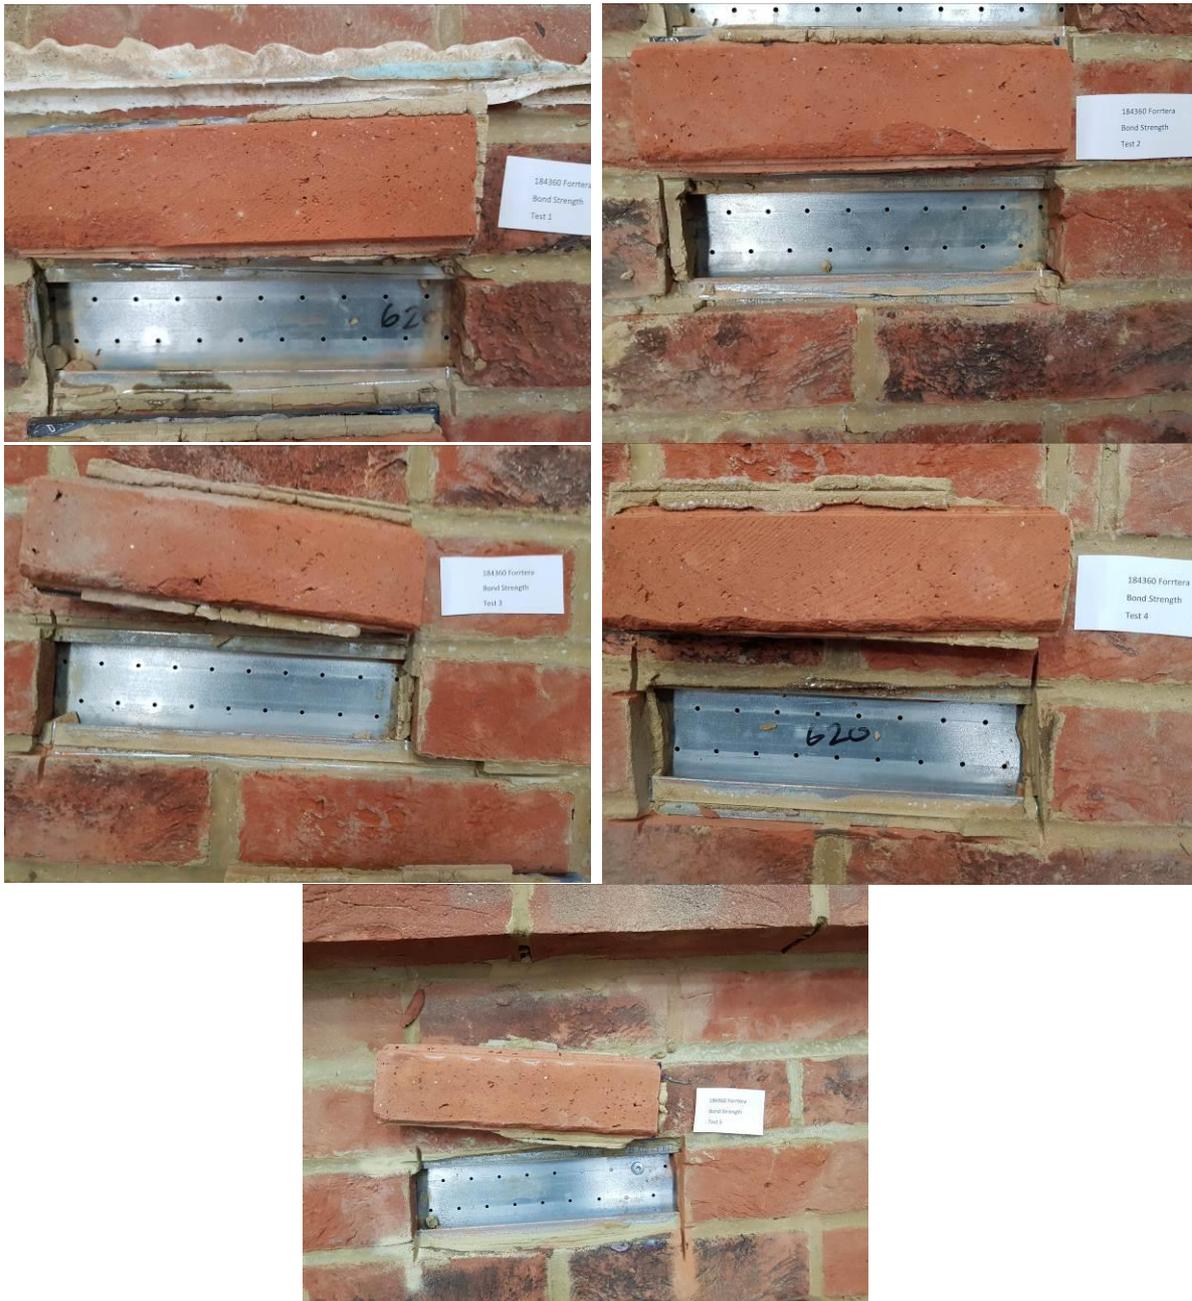
Plate 22 – Chelsea Smoked Red Brick Slips Bond Strength Tests – after Hygrothermal, Freeze/Thaw Testing and Water-Tightness Testing

Location	Pull-Off Strength (N/mm ²)	Mode of Failure
1	0.046	Pull Out From Rail
2	0.078	Pull Out From Rail
3	0.031	Pull Out From Rail
4	0.088	Pull Out From Rail
5	0.050	Pull Out From Rail
Mean	0.059	-
