# HANDLING OF T-BEAMS

This guidance note gives the reader information on how to handle prestressed T-beams.

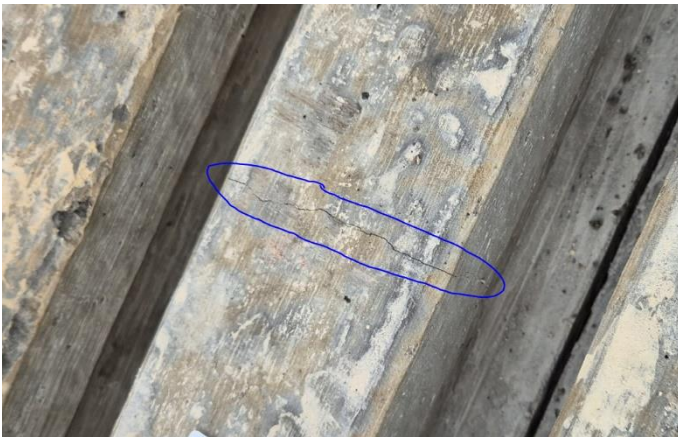
Figure 1 – micro crack present on top surface

Micro cracks can be present in beams that have been stored with bearers too far from the ends of the beams. The self weight of the beam which cantilevers from the bearer induces the crack. If stored for a long period of time the cracks can propagate into large cracks which may render the beam unusable. Micro cracks can also occur if the beams are handled with forks too close together or if the beams are picked up in double or triple stack heights with the bottom stack exhibiting the micro cracks. Traversing over rough ground can also cause micro cracks to occur.

Figures 1 and 2 show the typical arrangement of micro cracks.

Micro cracks are a common occurrence and do not affect the long term structural performance of the beams.

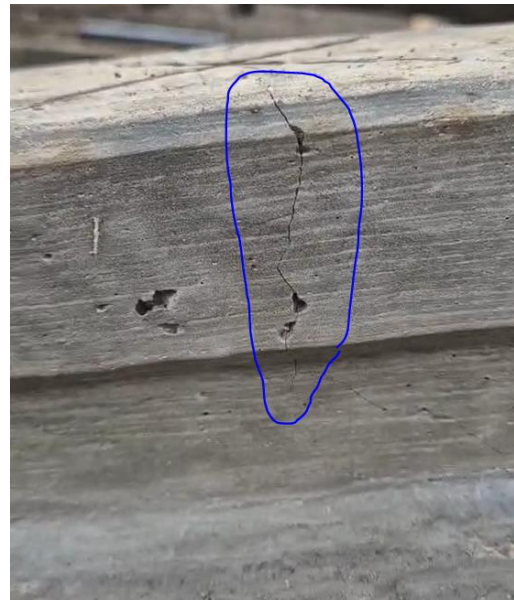
Figure 2 – micro crack propagating down the top part of the beam
